**Flood Control Project Maintenance
Levee Inspections**

Maintenance Issue Types Only, Levee Inspection Report By Mile - Fall 2016

Sacramento Maintenance Yard Willow Slough Bypass

Waterway	Bank	Unit Miles	Inspection Start/End	Inspector
Unit No. 01 Willow Slough Bypass or North Levee	Left	5.05	10/11/2016 10/11/2016	Oleg Yakimov

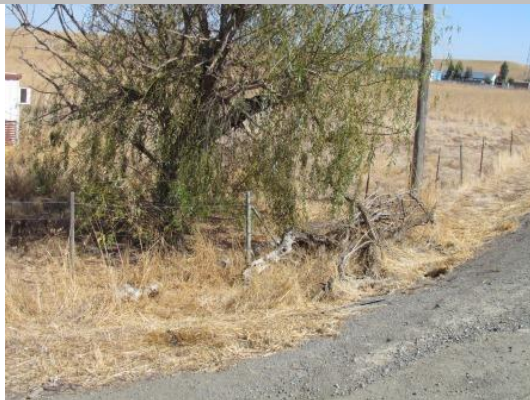
Photo 1 of 1 : FA_2016_ST0012_295_9_20161011_00017.jpg

LM Start	1.65	Rating **	M	Issue No.	9
LM End	1.65	Issue Type +	Ma	Location *	LS
Category	Earthen Levee		GPS Latitude/Longitude		
			Start	End	
Item	Encroachments		38.590408°	38.590408°	
			-121.695755°	-121.695755°	
DWR ID	DWR_ST0012_01_f_2016_9				
Comment Code					
DE : Debris					
Inspector Comment

View of debris on landward side of the levee near abandoned buildings.
Fall 2016.

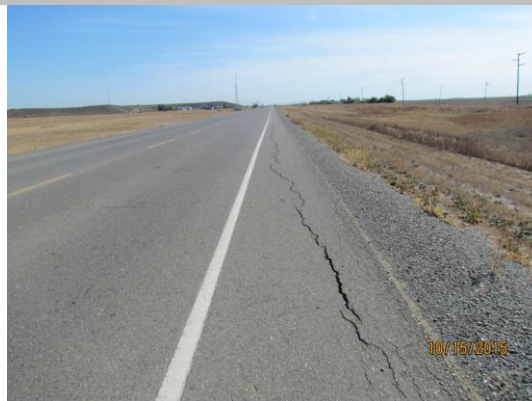
Photo 1 of 3 : FA_2016_ST0012_295_15_20160913_00007.jpg

LM Start	1.86	Rating **	A/W	Issue No.	15
LM End	1.88	Issue Type +	Ma	Location *	CR
Category	Earthen Levee			GPS Latitude/Longitude	
				Start	End
Item	Cracking			38.590378 °	38.590379 °
				-121.699630 °	-121.699920 °
DWR ID	DWR_ST0012_01_f_2015_15				
Comment Code					
CR1 : Monitor and have inspected by geotechnical engineer.					
Inspector Comment					
Cracks starting to form on the waterward slope.

Perspective view of the crack on the crown of the levee looking downstream. Fall 2015.

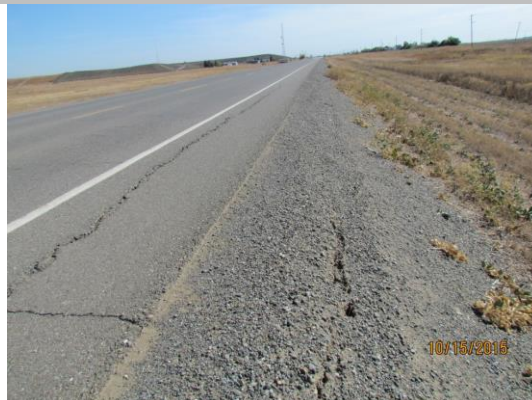
Photo 2 of 3 : FA_2016_ST0012_295_15_20160913_00008.jpg

Cracks are starting to form on the waterward slope of the levee looking downstream. Fall 2015.

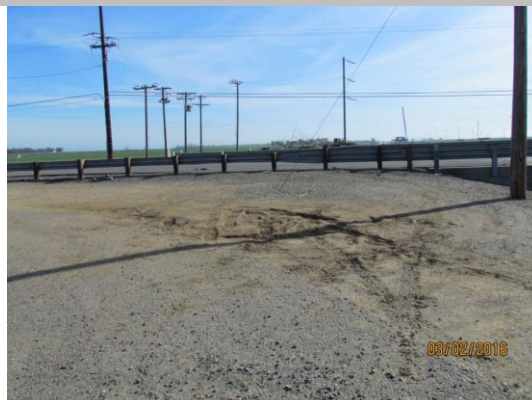
Photo 1 of 1 : FA_2016_ST0012_295_18_20160913_00014.jpg

LM Start	3.54	Rating **	M	Issue No.	18
LM End	3.54	Issue Type +	Ma	Location *	CR
Category	Earthen Levee			GPS Latitude/Longitude	
				Start	End
Item	Crown Surface / Depressions / Rutting			38.590685 °	38.590685 °
				-121.730657 °	-121.730657 °
DWR ID	DWR_ST0012_01_s_2016_18				
Comment Code					
C2 : Repair depressions or ruts in the crown or slope.					
Inspector Comment

View of the ruts caused by vehicles on the crown of the levee looking downstream. Spring 2016.

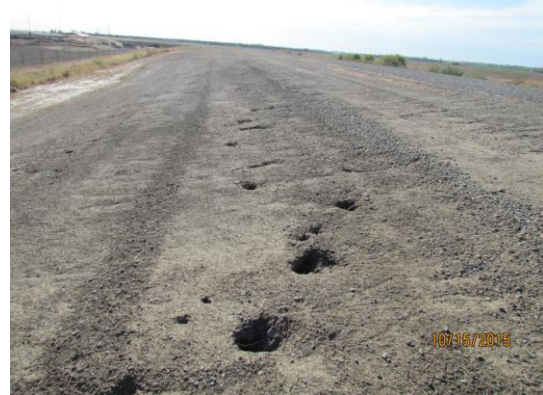
Photo 1 of 2 : FA_2016_ST0012_295_12_20160913_00004.jpg

LM Start	3.90	Rating **	M	Issue No.	12
LM End	3.90	Issue Type +	Ma	Location *	LS
Category	Earthen Levee			GPS Latitude/Longitude	
				Start	End
Item	Cracking			38.594149 °	38.594149 °
				-121.735254 °	-121.735254 °
DWR ID	DWR_ST0012_01_f _ 2015_12				
Comment Code					
CR1 : Monitor and have inspected by geotechnical engineer.					
Inspector Comment					
The sinkholes are caused by the material of the levee and runoffs. These are not rodent holes.

View of the sinkholes on the landward side of the levee looking downstream. Fall 2015.

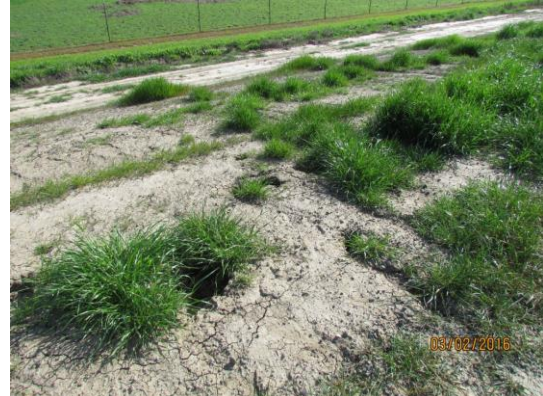
Photo 2 of 2 : FA_2016_ST0012_295_12_20160913_00005.jpg

View of the sinkholes on the landward side of the levee. Sinkholes are caused due to material of the levee and runoffs. Spring 2016.

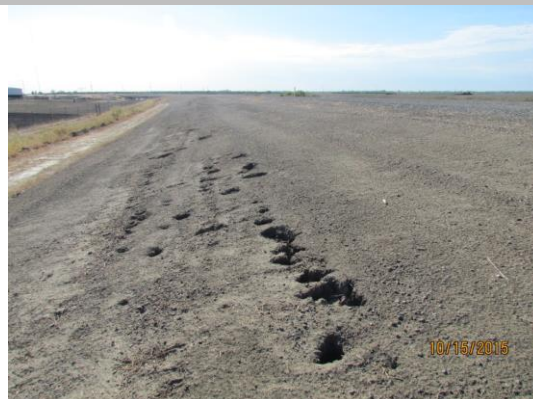
Photo 1 of 1 : FA_2016_ST0012_295_11_20160913_00003.jpg

LM Start	3.94	Rating **	M	Issue No.	11
LM End	3.94	Issue Type +	Ma	Location *	LS
Category	Earthen Levee			GPS Latitude/Longitude	
				Start	End
Item	Cracking			38.594645°	38.594645°
				-121.735712°	-121.735712°
DWR ID	DWR_ST0012_01_f_2015_11				
Comment Code					
CR1 : Monitor and have inspected by geotechnical engineer.					
Inspector Comment					
The sinkholes are caused by the material of the levee and runoffs. These are not rodent holes.

View of the sinkholes on the landward side of the levee looking downstream. Fall 2015.

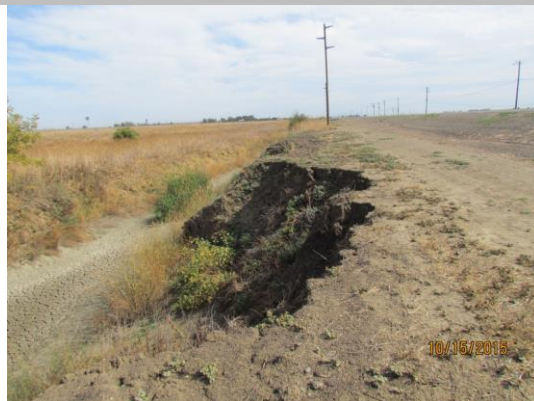
Photo 1 of 1 : FA_2016_ST0012_296_8_20160913_00005.jpg

LM Start	1.77	Rating **	M	Issue No.	8
LM End	1.77	Issue Type +	Ma	Location *	WS
Category	Earthen Levee			GPS Latitude/Longitude	
				Start	End
Item	Erosion / Bank Caving			38.589966 °	38.589966 °
				-121.727072 °	-121.727072 °
DWR ID	DWR_ST0012_02_s_2012_8				
Comment Code					
E2 : Schedule repair of erosion site prior to the next inspection.					
Inspector Comment

View of the erosion on the edge of the channel looking downstream. Fall 2015.

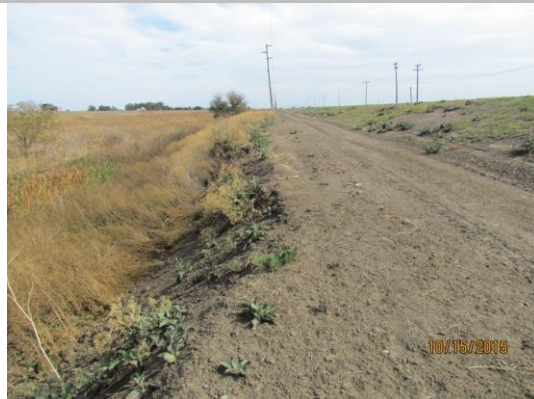
Photo 1 of 2 : FA_2016_ST0012_296_5_20160913_00001.jpg

LM Start	2.04	Rating **	M	Issue No.	5
LM End	2.04	Issue Type +	Ma	Location *	WS
Category	Earthen Levee			GPS Latitude/Longitude	
				Start	End
Item	Erosion / Bank Caving			38.589906 °	38.589906 °
				-121.722218 °	-121.722218 °
DWR ID	DWR_ST0012_02_s_2012_5				
Comment Code					
E1 : Note and monitor erosion site.					
Inspector Comment

View of the erosion on the edge of the channel on the waterward side of the levee looking downstream. Fall 2015.

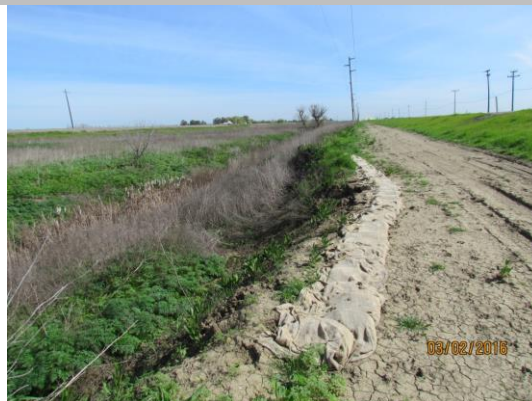
Photo 2 of 2 : FA_2016_ST0012_296_5_20160913_00002.jpg

LM Start	2.04	Rating **	M	Issue No.	5 (cont)	
LM End	2.04	Issue Type +	Ma	Location *	WS	
Category	Earthen Levee			GPS Latitude/Longitude		
				Start		End
Item	Erosion / Bank Caving			38.589906°	38.589906°	
				-121.722218°	-121.722218°	
DWR ID	DWR_ST0012_02_s_2012_5					
Comment Code						
E1 : Note and monitor erosion site.						
Inspector Comment

View of the erosion on the edge of the channel on the waterward side of the levee looking downstream. Spring 2016.

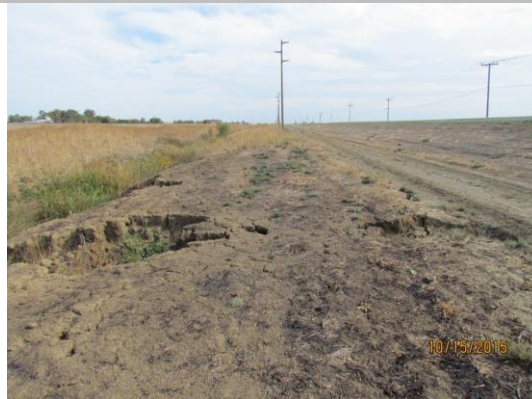
Photo 1 of 2 : FA_2016_ST0012_296_19_20160913_00018.jpg

LM Start	2.25	Rating **	M	Issue No.	19
LM End	2.25	Issue Type +	Ma	Location *	WS
Category	Earthen Levee			GPS Latitude/Longitude	
				Start	End
Item	Erosion / Bank Caving			38.589845°	38.589845°
				-121.718292°	-121.718292°
DWR ID	DWR_ST0012_02_f_2015_19				
Comment Code					
E1 : Note and monitor erosion site.					
Inspector Comment					
Erosion creeping onto toe road.

View of the erosion at the edge of the channel on the waterward side of the levee looking downstream. Fall 2015.

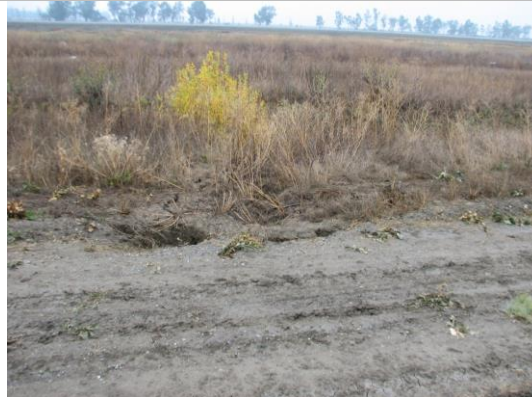
Photo 1 of 2 : FA_2016_ST0012_296_10_20160913_00008.jpg

LM Start	2.82	Rating **	M	Issue No.	10
LM End	2.82	Issue Type +	Ma	Location *	WS
Category	Earthen Levee			GPS Latitude/Longitude	
				Start	End
Item	Erosion / Bank Caving			38.589691°	38.589691°
				-121.707740°	-121.707740°
DWR ID	DWR_ST0012_02_f_2014_10				
Comment Code					
E1 : Note and monitor erosion site.					
Inspector Comment

Erosion on toe road. Fall 2014.

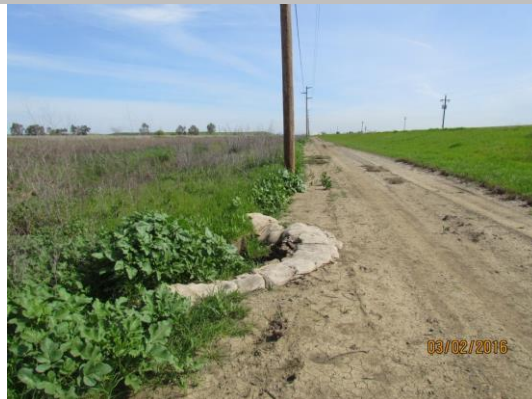
Photo 2 of 2 : FA_2016_ST0012_296_10_20160913_00009.jpg

View of the erosion on the toe road looking downstream. Spring 2016.

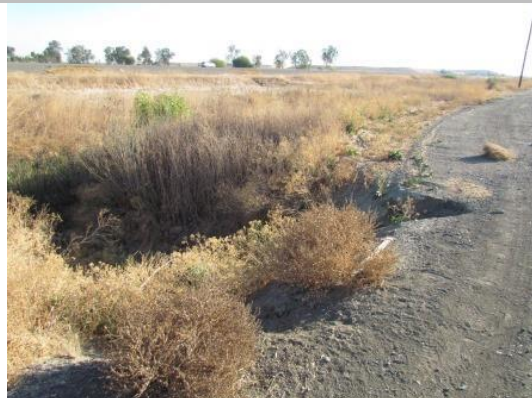
Photo 1 of 3 : FA_2016_ST0012_296_9_20161011_00041.jpg

LM Start	2.97	Rating **	M	Issue No.	9
LM End	2.97	Issue Type +	Ma	Location *	WS
Category	Earthen Levee			GPS Latitude/Longitude	
				Start	End
Item	Erosion / Bank Caving			38.589686 °	38.589686 °
				-121.705041 °	-121.705041 °
DWR ID	DWR_ST0012_02_f_2014_9				
Comment Code					
E2 : Schedule repair of erosion site prior to the next inspection.					
Inspector Comment

An updated view of erosion site on waterward side of the levee that keeps on growing. Fall 2016.

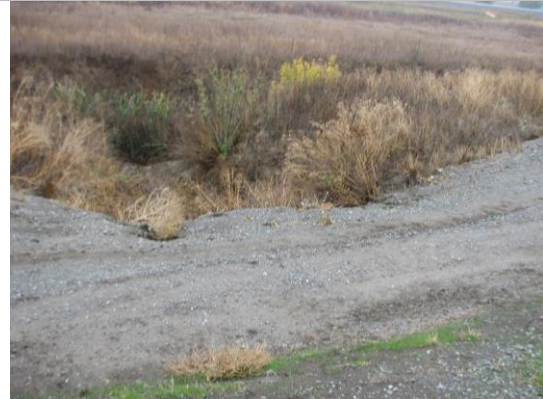
Photo 2 of 3 : FA_2016_ST0012_296_9_20160913_00006.jpg

Erosion on toe road. Fall 2014.

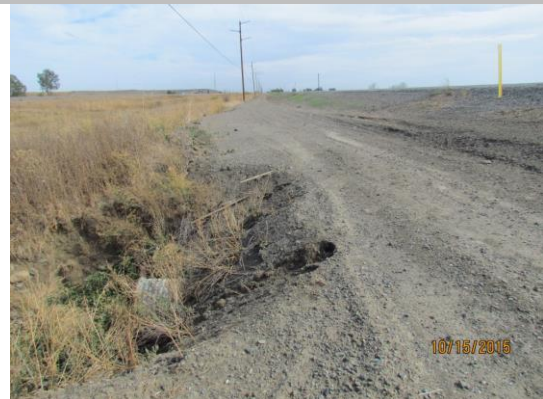
Photo 3 of 3 : FA_2016_ST0012_296_9_20160913_00007.jpg

View of the erosion on the waterward side of the levee looking downstream. Fall 2015.

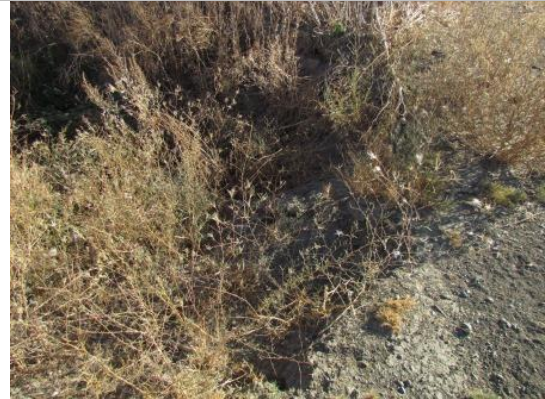
Photo 1 of 3 : FA_2016_ST0012_296_11_20161011_00037.jpg

LM Start	4.29	Rating **	M	Issue No.	11
LM End	4.29	Issue Type +	Ma	Location *	WS
Category	Earthen Levee			GPS Latitude/Longitude	
				Start	End
Item	Erosion / Bank Caving			38.589550 °	38.589550 °
				-121.680632 °	-121.680632 °
DWR ID	DWR_ST0012_02_f_2014_11				
Comment Code					
E2 : Schedule repair of erosion site prior to the next inspection.					
Inspector Comment

An updated view of the erosion site that keeps on growing toward WS levee slope. Fall 2016.

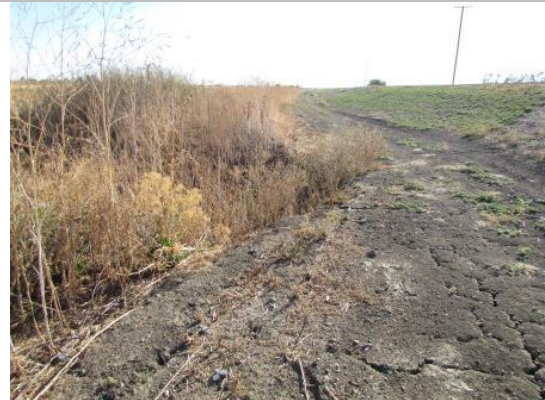
Photo 2 of 3 : FA_2016_ST0012_296_11_20161011_00035.jpg

Perspective view of the site. Fall 2016.

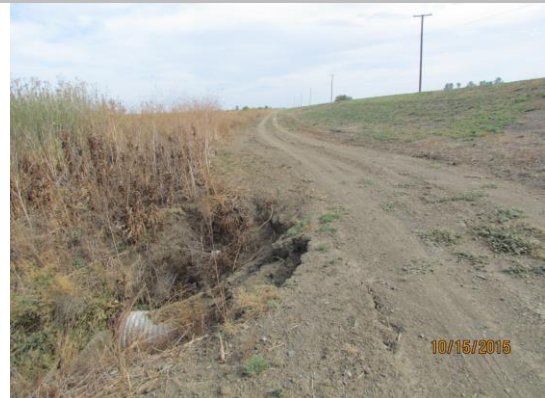
Photo 3 of 3 : FA_2016_ST0012_296_11_20160913_00010.jpg

View of the erosion at the edge of the channel on the waterward side of the levee looking downstream. Fall 2015.

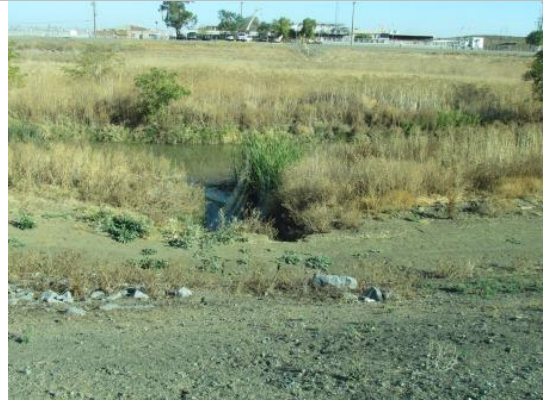
Photo 1 of 3 : FA_2016_ST0012_296_15_20161011_00034.jpg

LM Start	5.05	Rating **	M	Issue No.	15
LM End	5.05	Issue Type +	Ma	Location *	WS
Category	Earthen Levee			GPS Latitude/Longitude	
				Start	End
Item	Erosion / Bank Caving			38.589570 °	38.589570 °
				-121.666588 °	-121.666588 °
DWR ID	DWR_ST0012_02_s_2015_15				
Comment Code					
E2 : Schedule repair of erosion site prior to the next inspection.					
Inspector Comment

An updated view of the erosion site that keeps on growing toward WS levee slope. Fall 2016.

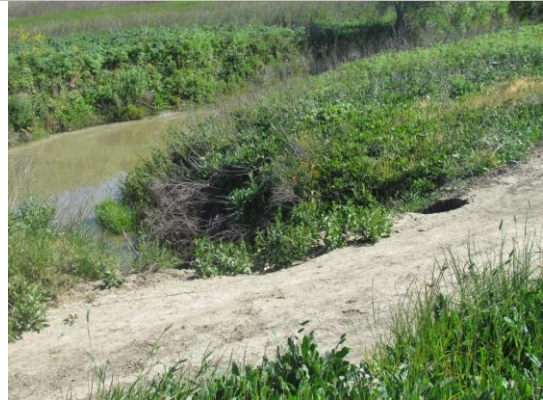
Photo 2 of 3 : FA_2016_ST0012_296_15_20160913_00014.jpg

View of the erosion on the edge of the channel on the waterward side of the levee. Spring 2015.

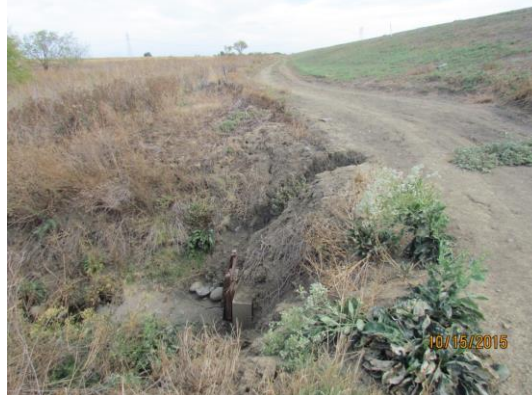
Photo 3 of 3 : FA_2016_ST0012_296_15_20160913_00015.jpg

View of the erosion at the edge of the channel on the waterward side of the levee looking downstream. Fall 2015.

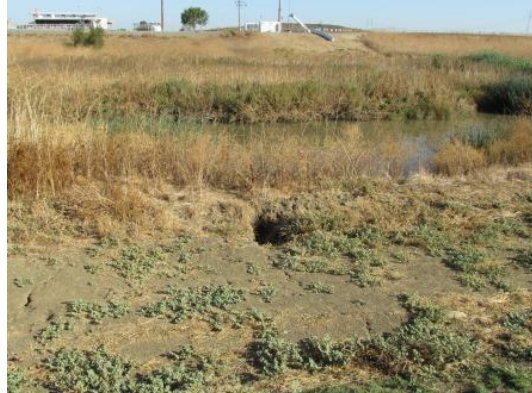
Photo 1 of 1 : FA_2016_ST0012_296_17_20161011_00033.jpg

LM Start	5.09	Rating **	M	Issue No.	17
LM End	5.09	Issue Type +	Ma	Location *	WS
Category	Earthen Levee			GPS Latitude/Longitude	
				Start	End
Item	Erosion / Bank Caving			38.589565 °	38.589565 °
				-121.665731 °	-121.665731 °
DWR ID	DWR_ST0012_02_f_2016_17				
Comment Code					
E1 : Note and monitor erosion site.					
Inspector Comment

View of a site that may become a larger erosion site in the future. Waterward side of the levee looking downstream. Fall 2016.

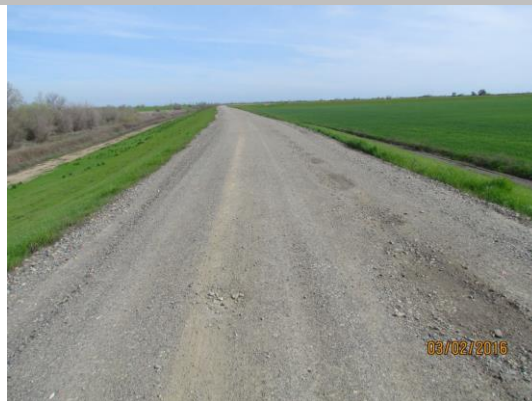
Photo 1 of 1 : FA_2016_ST0012_296_25_20160913_00025.jpg

LM Start	7.15	Rating **	M	Issue No.	25
LM End	7.46	Issue Type +	Ma	Location *	CR
Category	Earthen Levee			GPS Latitude/Longitude	
				Start	End
Item	Crown Surface / Depressions / Rutting			38.574860 °	38.574293 °
				-121.644047 °	-121.638713 °
DWR ID	DWR_ST0012_02_s_2016_25				
Comment Code					
C3 : Add appropriate gravel or road base. Grade and compact.					
Inspector Comment					
Crown needs to be regraded.

View of the crown of the levee looking downstream. Road needs to be regraded. Spring 2016.
